# INDOOR AIR QUALITY ASSESSMENT

## High School of Commerce 415 State Street Springfield, Massachusetts

Prepared by: Massachusetts Department of Public Health Bureau of Environmental Health Assessment May, 2002

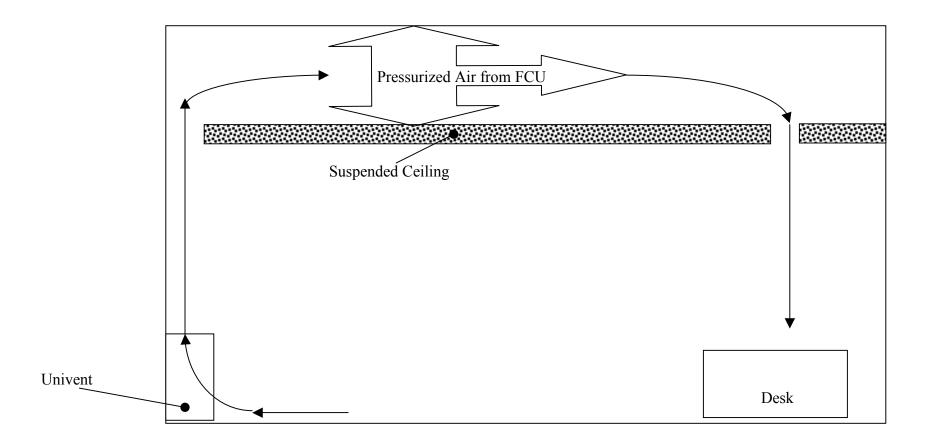
Figure 2
Pressurization of Ceiling Plenum in Classrooms

A number of areas throughout the building demonstrated conditions that can result in the aerosolization of materials associated with irritant symptoms into the school environment. Classrooms in the 1915 building had a suspended ceiling installed during renovations. In order to not block windows, bays were built into the ceiling tile system. These bays have triangle-shaped tiles installed *vertically* (see Picture 7) in the sides of each bay to provide a continuous ceiling system. This configuration can lead to the triangular ceiling tiles falling into the ceiling plenum. A number of classrooms have triangular ceiling tiles that are ajar. Ceiling tiles, particularly those above univents, were found leaning into the ceiling plenum, which allows for air expelled from the univent to enter the space between the original and suspended ceilings (see Figure 2). Air forced into the ceiling plenum then pressurizes this space, which can then force air through spaces in the suspended ceiling. Through this pathway, particles in the air stream produced by the univent and that exist above the suspended ceiling can be directed towards the classroom interior. Dust, dirt and other particles can be irritating to the eyes, nose and throat.
